## **DURANT CITY UTILITIES AUTHORITY**

**February 13, 2024**

# ***Sanitary Sewer Condition Assessment and Infiltration/Inflow Reduction Program***

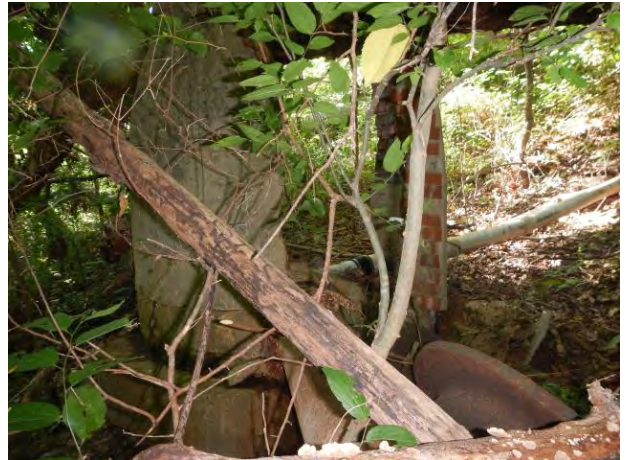
Manhole 12210 collapsed with exposed mains

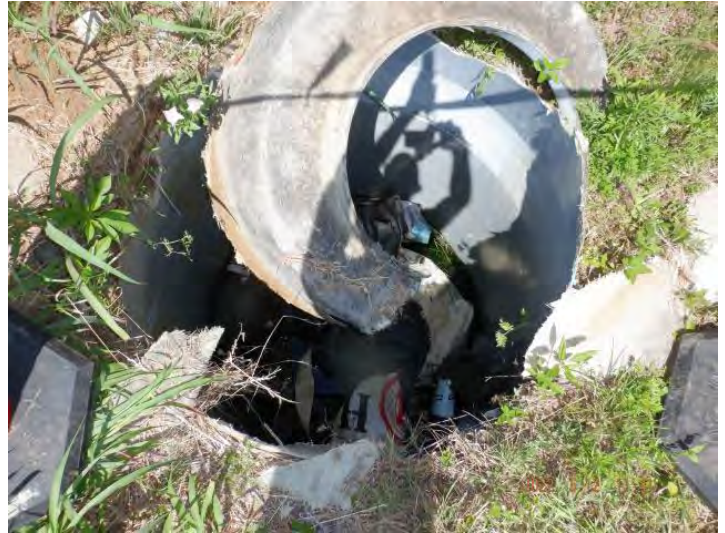
Manhole 24072 – Fiberglass manhole destroyed and full of debris

| Basin | Manhole ID | Asset Type | Condition Rating | Inspection Status | Address | Lid Type | Vent Holes | Inflow Dish | Inflow Potential | Surface Cover | Surface Material | Manhole Grade | Grade (Inches) | Manhole Diameter | MH Material | Rim to Invert (feet) | Area Photo File | Internal Photo File | Map Number | GPS Lat | GPS Lon | Vault Size | Material If Other | Debris Depth (Inches) | Comments |
|---|---|---|---|---|---|---|---|---|---|---|---|---|---|---|---|---|---|---|---|---|---|---|---|---|---|
| 7 | 24072 | Manhole | E | Yes | 807 SE 3RD AVE. | | | | | Road Shoulder | Unpaved | Above Grade | 6 | Std 48 Round | Fiberglass | 0 | 24072A0027.jpg | 24072I0028.jpg | E04 | 33.98 | -96.3725 | | | | NO LID FOUND, MH IS UNSAFE . FILLED WITH DEBRIS |
