## **DURANT CITY UTILITIES AUTHORITY**

**February 13, 2024**

# ***Sanitary Sewer Condition Assessment and Infiltration/Inflow Reduction Program***

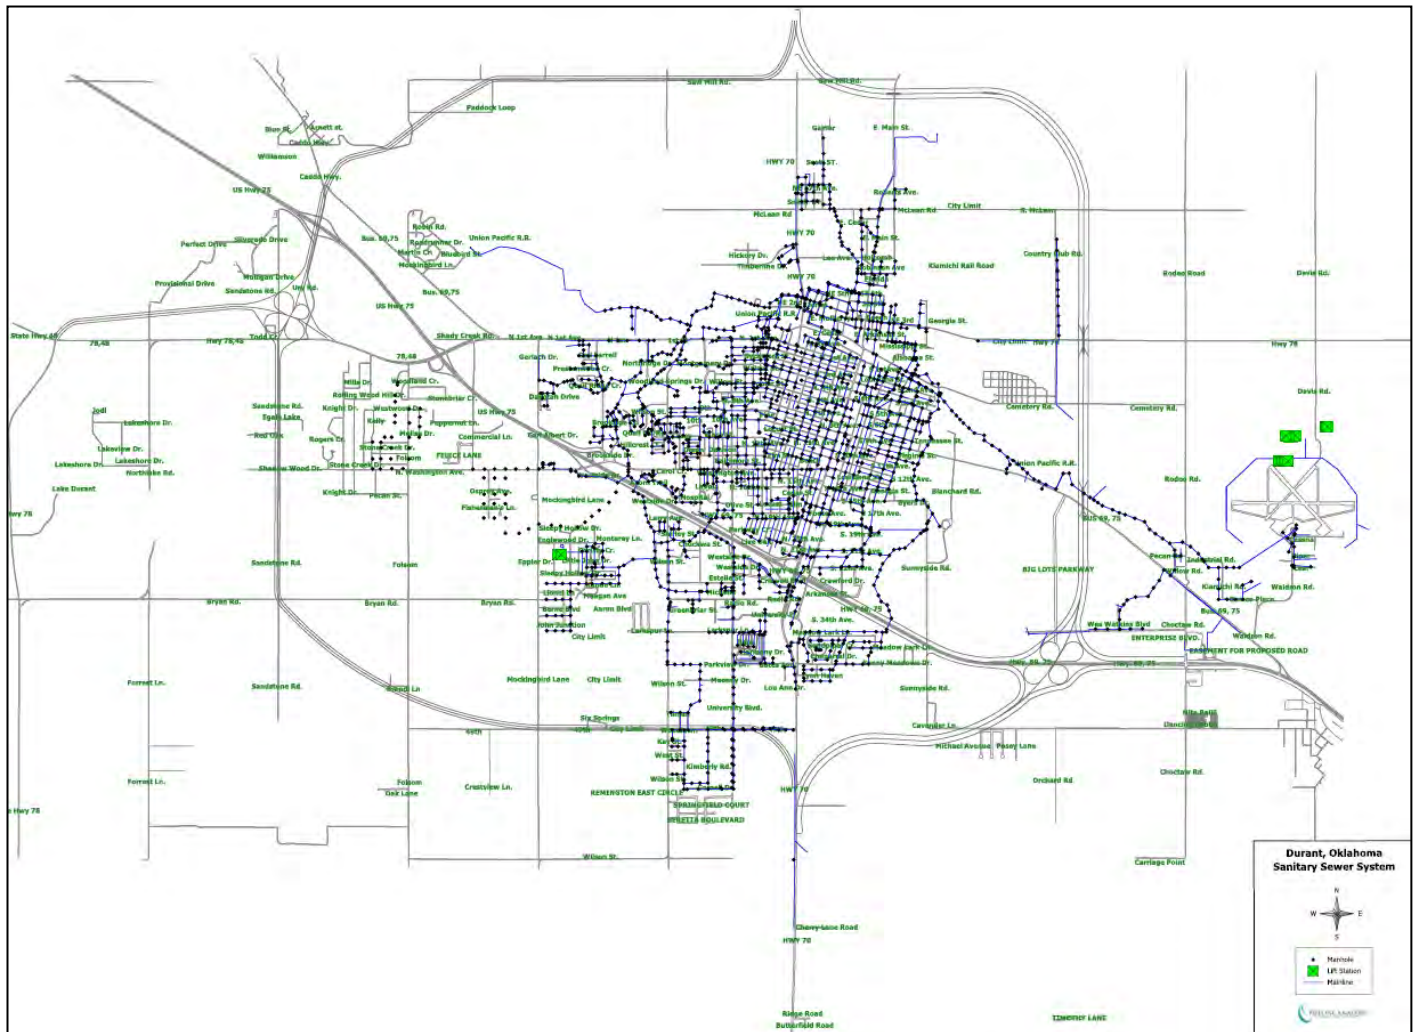
Figure 1  
Study Area Map

Manhole inspection was performed on all accessible manholes within the designated study area. Approximately 2,495 structures consisting of mainline cleanouts, manholes and end of line segments are within the collection system. Figure 1 presents wastewater collection system and the manholes inspected for the City of Durant. The following inspections were performed:
